Central Waste Complex (CWC)

Compliance Inspection and Enforcement

2017 CWC Inspection

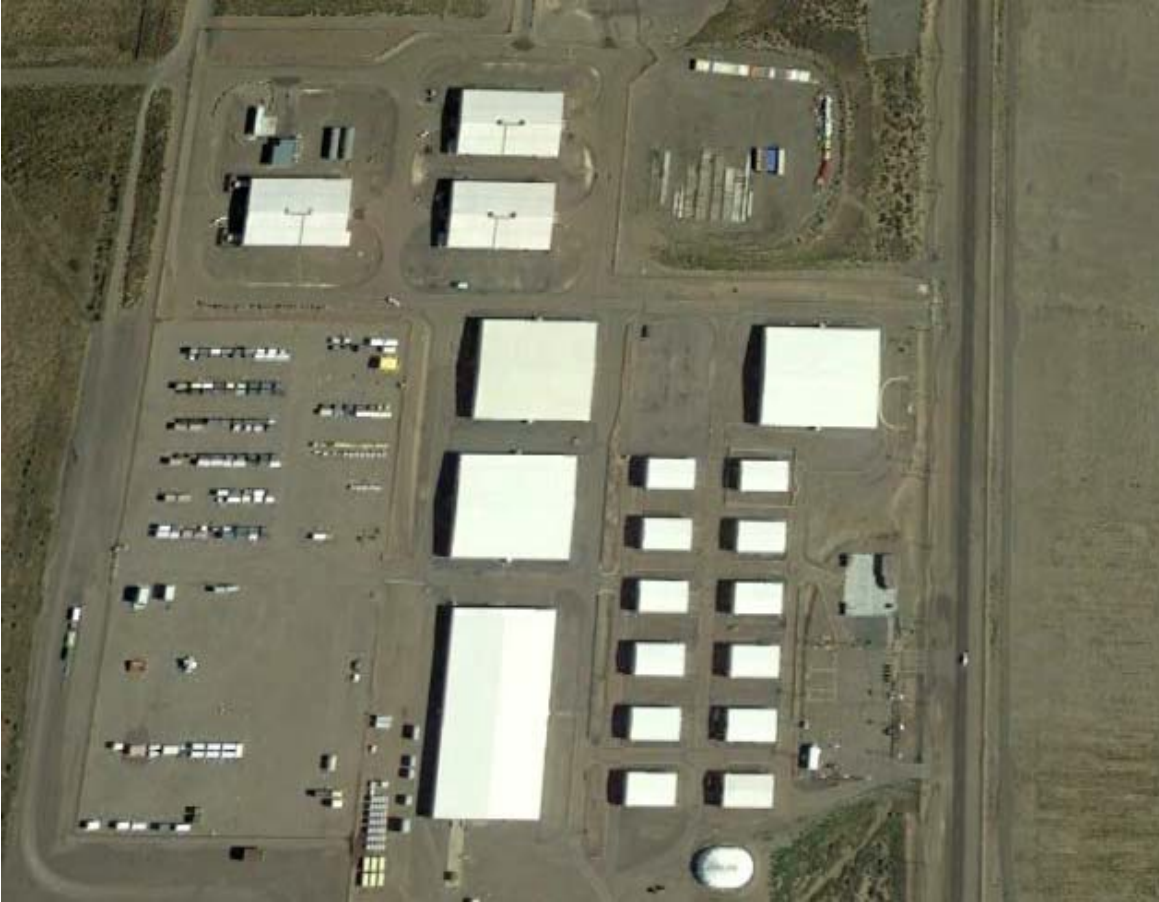
The Central Waste Complex (CWC) facility

- Approximately 43 buildings and structures
- More than 10,000 individual waste containers
- Outside storage of containers retrieved per M-091 milestone series
- Adjacent outside storage area for PFP waste is not subject to M-091, and is subject to CERCLA (not a HWMU)

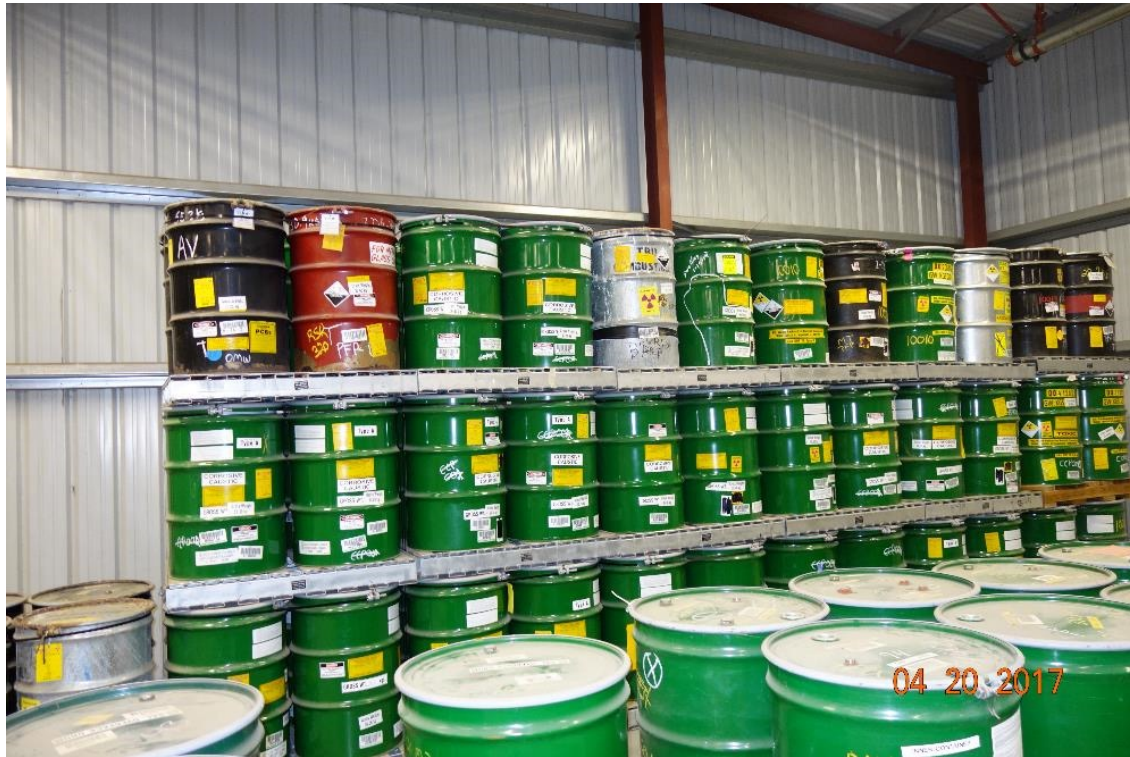
DSC01608 – Area where Container 0049231 is being stored

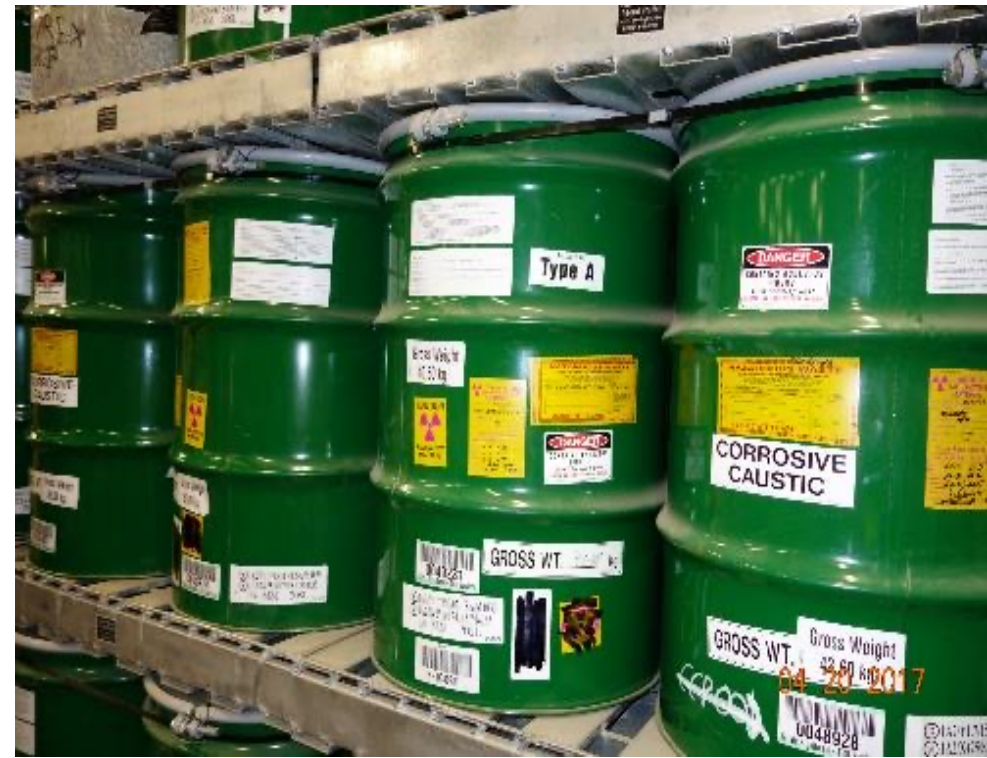
DSC01605 – Container 0049231

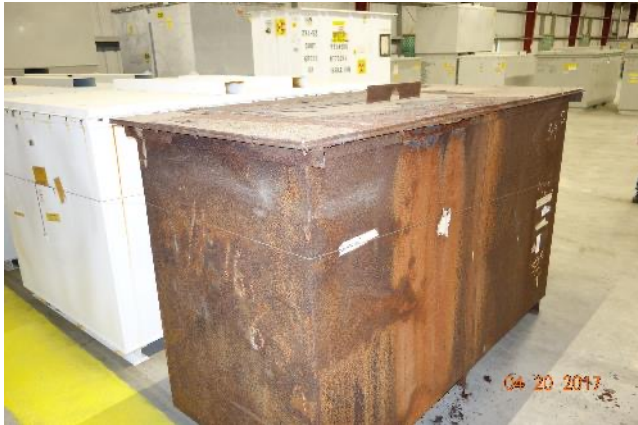
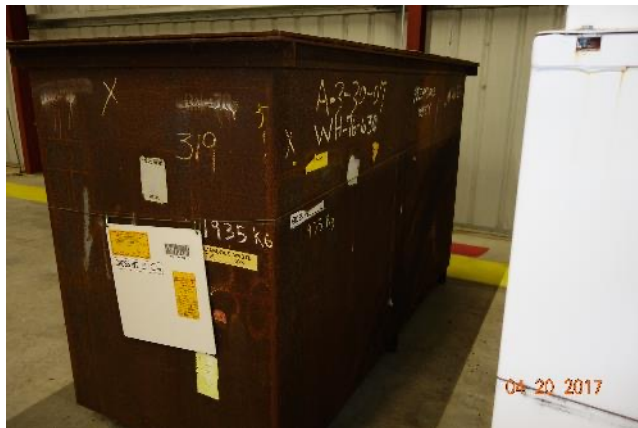
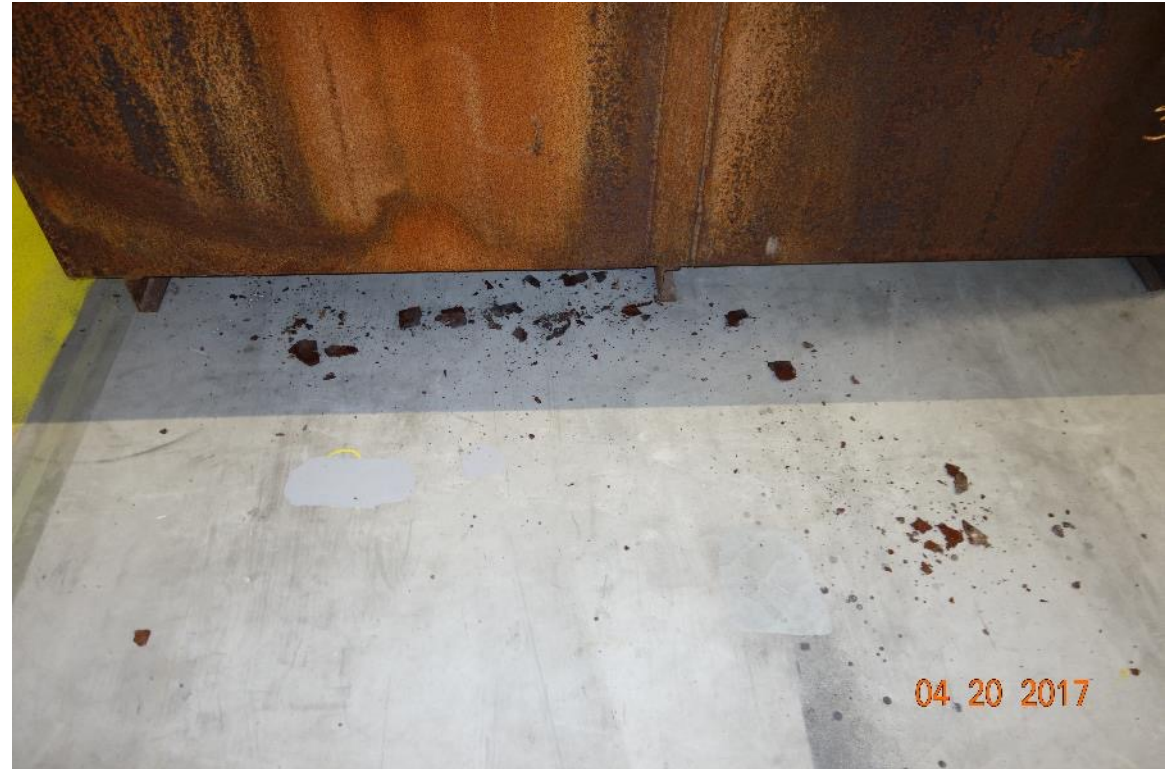
Rusty debris at the base of the container

- Non-Compliance #1 – Major Risk Labeling – Ecology reviewed operating records and observed waste codes requiring additional major risk labeling on containers.
 - Resolution - Discussed later.
- Non-Compliance #2 – Containers not in good condition.
 - Resolution - On February 7, 2018 - Ecology received records and photos showing that Container WH-76-630 was repackaged into a container in good condition.
- Non-Compliance #3 – Incomplete Dangerous Waste Training Plans with grouped job positions.
 - Resolution - On June 26, 2018, Ecology received an updated Dangerous Waste Training Plan with all job positions identified.
- Non-Compliance #4 – Failure to provide requested operating records.
 - Resolution - Non-compliance closed at time of report issuance, as records provided on August 16, 2017, before the report was issued.

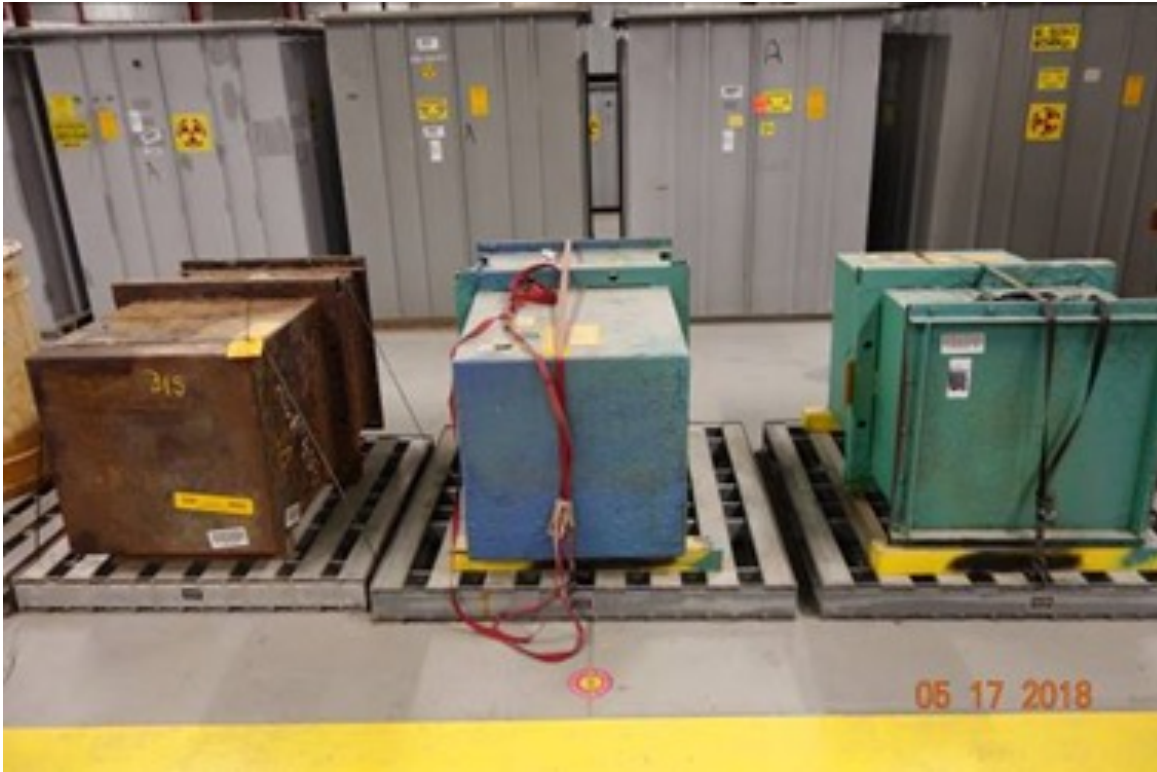
- Only one non-compliance cited – Major Risk Labeling – Ecology reviewed operating records and observed waste codes requiring additional major risk labeling on three containers.
- Container 202A75013, labeled as hazardous waste was covered in rust and appeared to be scaling in places. The container did not have the proper risk label.
- See next slide for resolution

- USDOE/Contractor – Updated procedures to ensure that all containers accepted at Solid Waste Operations Complex facilities be labeled with the appropriate hazard label.
- All containers at Solid Waste Operations Complex facilities with the risks/hazards of corrosive, reactive, or ignitable were labeled. A complete check through all containers was conducted and containers labeled for compliance with this.
- The agreement also included placing major risk (hazard) labels on the 22 containers referenced by previous inspection reports (e.g. 2017 & 2018 reports).
- Reference the USDOE-RL letter 19-ESQ-0054, dated March 21, 2019.
<https://pdw.hanford.gov/document/AR-01096>
